CROSS COUNTRY HOME INSPECTIONS, LLC 9723108320 jason@xcinspections.com https://www.xcinspections.com

1234 Main Street Blessing TX 77419

PROPERTY INSPECTION REPORT FORM

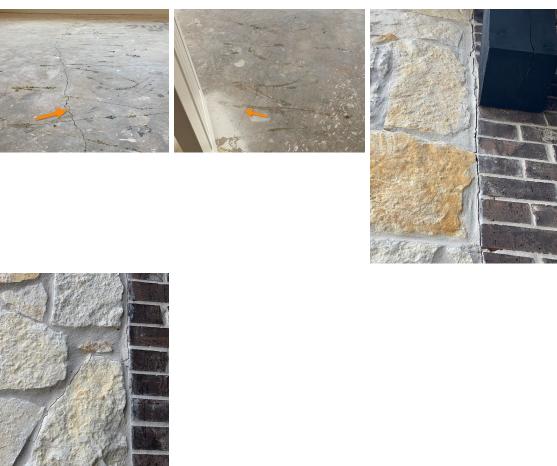
2: Heaving/Settling Recommendation

The floor slab and exterior masonry shows some minor signs of movement/settling due to soil movement. No signs of movement were apparent in the drywall at the time of the inspection. I recommend monitoring for further movement and hiring a qualified structural engineer to evaluate and advise on how to remedy.

Recommendation: Contact a qualified structural engineer.

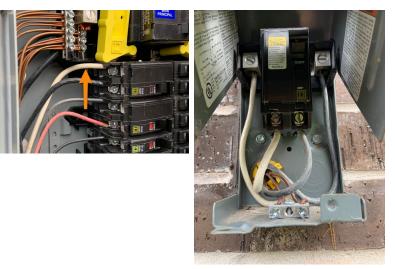
1: Improper Color Coding Recommendation

The hot (energized) conductors in a branch circuit are only allowed to be black or red. I recommend a qualified electrician properly identify the conductors inside the main panel and auxiliary panels.

Recommendation: Contact a qualified electrical contractor.

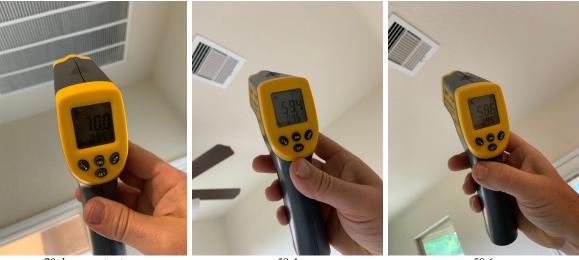
1: Temperature Split Across Cooling Coil Less Than 15 degrees Fahrenheit

70 degrees at return

Recommendation: Contact a qualified HVAC professional.
