YOUR INSPECTION REPORT

[REDACTED]
Blessing, TX 77419

Monday, January 2, 2023

PROPERTY INSPECTION REPORT FORM

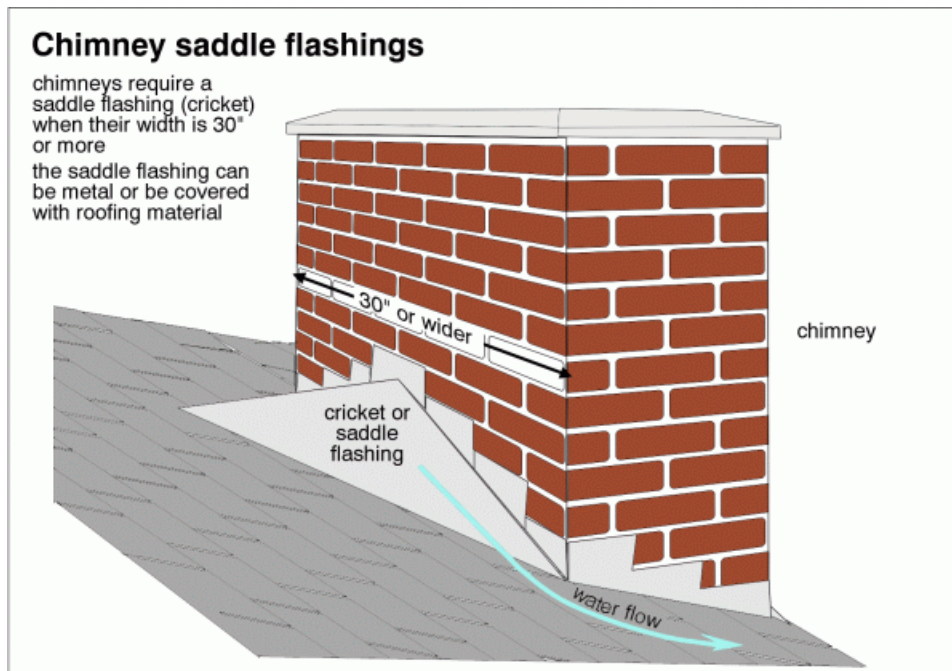
2. **Condition:** • Per current accepted trade practices, a chimney greater than 30" in width at the roof should have a cricket at the back side to prevent water penetration.

Implication(s): Chance of water damage to structure, finishes and contents

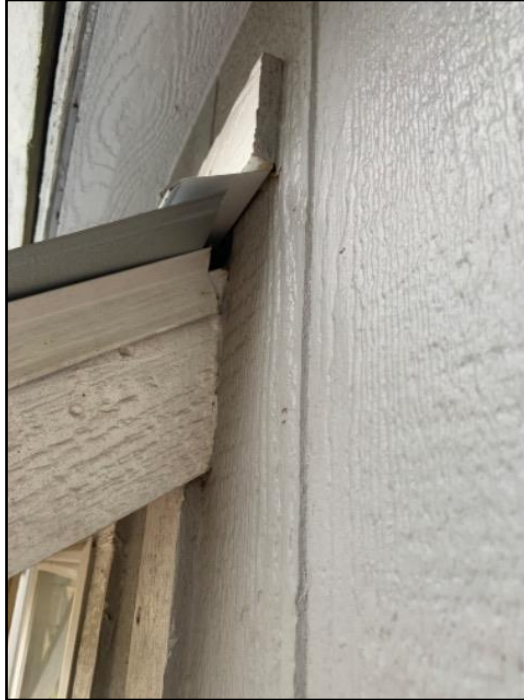
1. *Too short*

SLOPED ROOF FLASHINGS \ Drip edge flashings

3. **Condition:** • Too short

Implication(s): Chance of water damage to structure, finishes and contents

Location: East Exterior Wall

Task: Improve

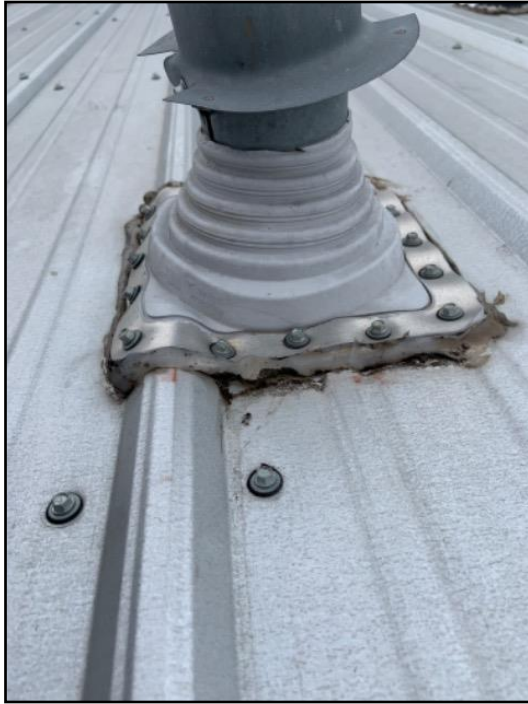
2. Vulnerable areas

SLOPED ROOF FLASHINGS \ Roof jacks

4. Condition: • Installation poor

Implication(s): Chance of water damage to structure, finishes and contents

Task: Repair

Time: Immediate

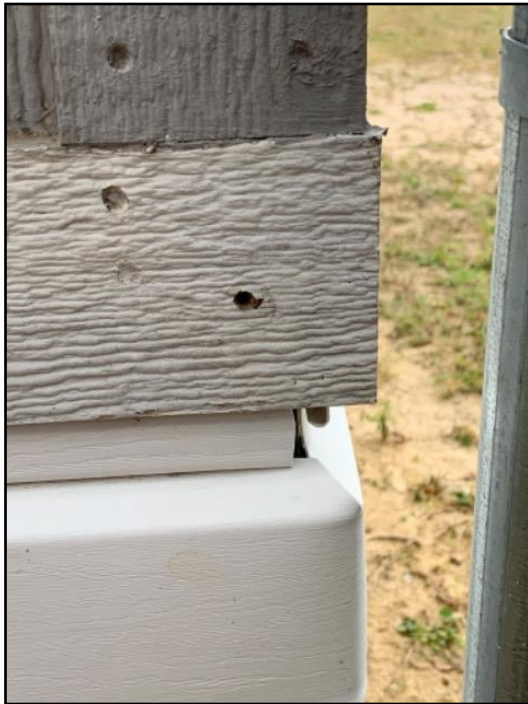
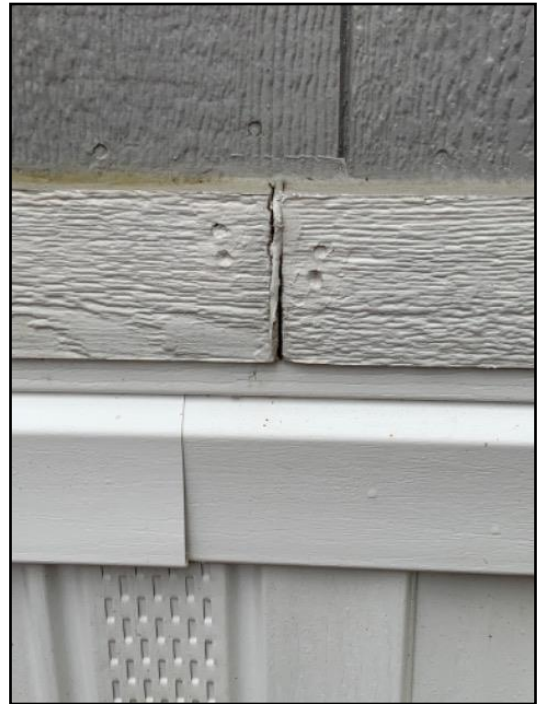
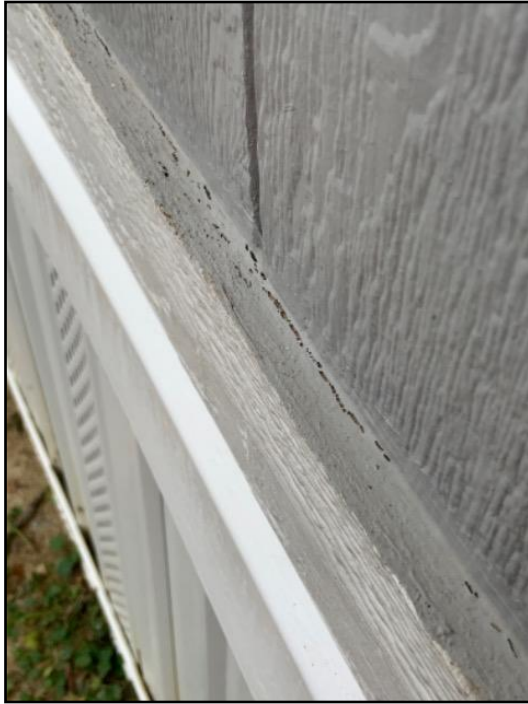
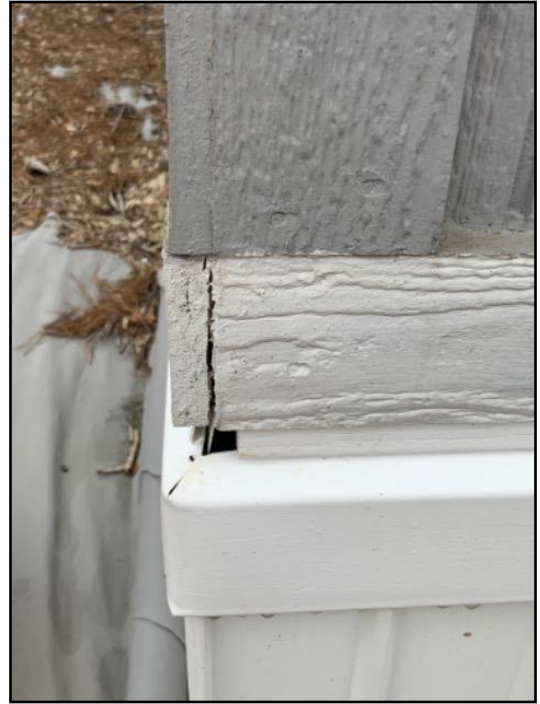
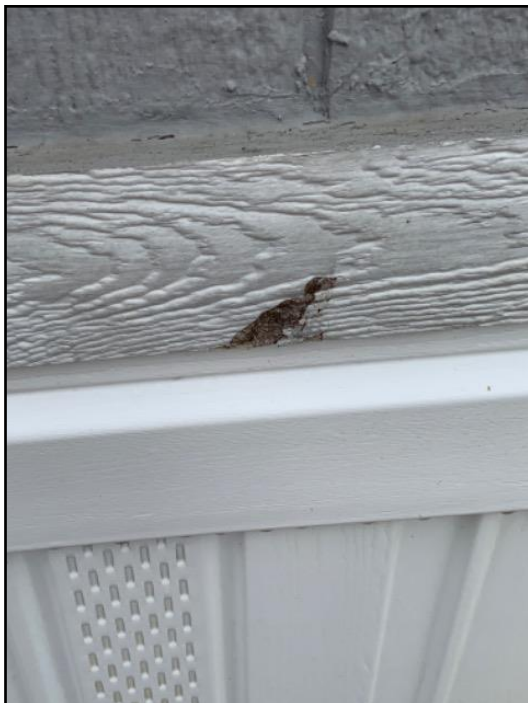
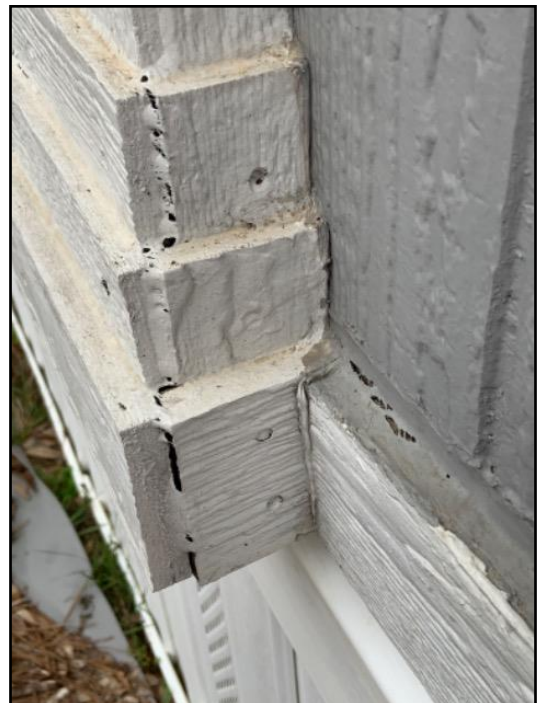
5. Condition: • Caulking missing or deteriorated

Implication(s): Chance of water damage to structure, finishes and contents | Material deterioration

Location: Various Exterior Wall

Task: Repair

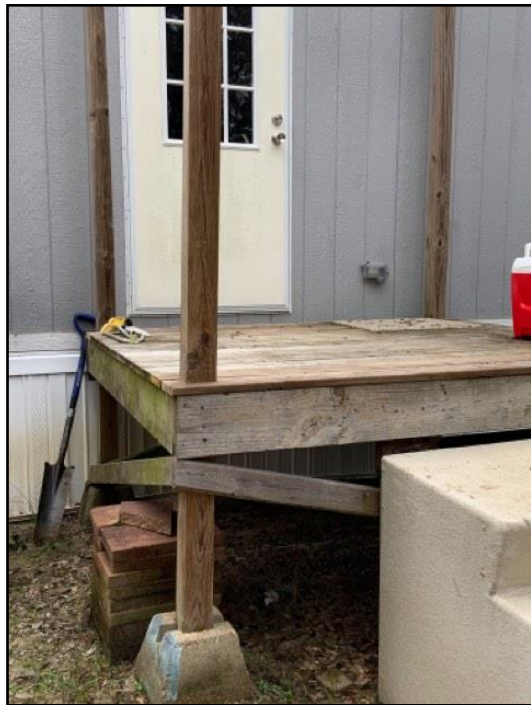
13. Missing

PORCHES, DECKS, STAIRS, PATIOS AND BALCONIES \ Handrails and guards

6. Condition: • Missing

Implication(s): Fall hazard

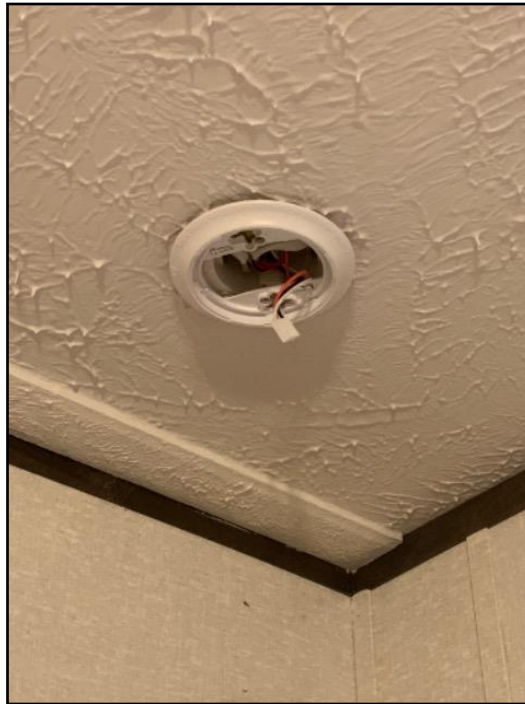
15. Missing

11. Condition: • Missing

Implication(s): Safety issue

Location: Master bedroom

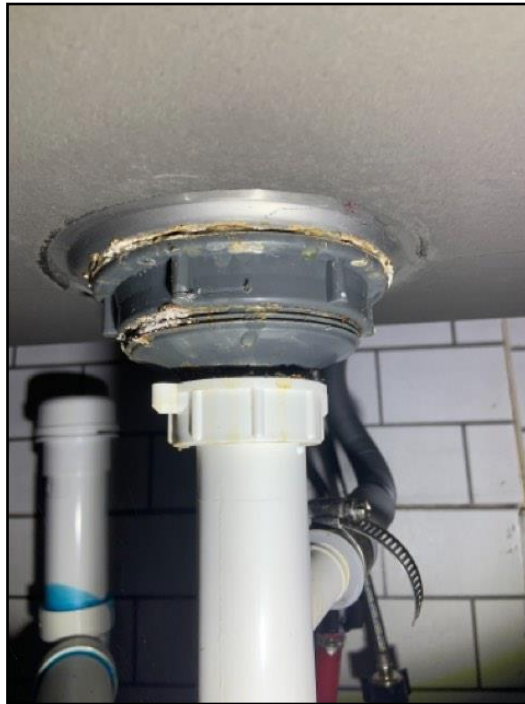
16. Leak

12. Condition: • Leak

Implication(s): Chance of water damage to structure, finishes and contents | Sewage entering the building

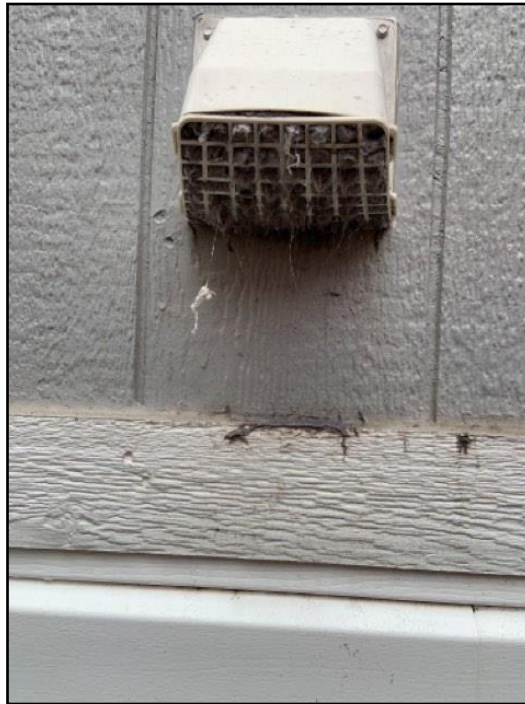
17. Dryer vent obstructed

15. Condition: • Dryer vent obstructed

Implication(s): Equipment ineffective | Fire hazard

16. Condition: • Per current accepted trade practices, the termination of the dryer vent at the exterior wall should not be covered with a screen. Due to this condition, I recommend the dryer vent tube be cleaned by an industry specialist and the screen removed.
