CROSS COUNTRY HOME INSPECTIONS, LLC 9723108320 jason@xcinspections.com https://www.xcinspections.com

1234 Main Street Blessing TX 77419

PROPERTY INSPECTION REPORT FORM

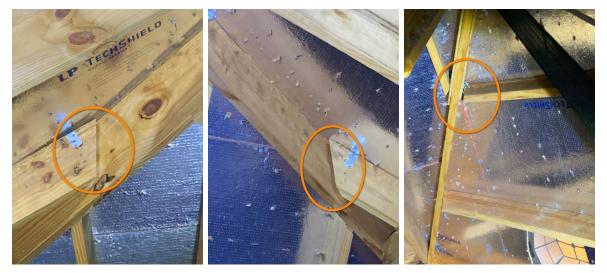
Plumb cuts where some rafters connect to the ridge were badly cut, leaving gaps. This condition reduces the strength of these connections. An evaluation and improvements should be made by a qualified framing contractor.

Recommendation: Contact a qualified general contractor.
